3809 REPORT OF INSPECTION

Date: April 16, 2002 Time: about 11:30 am Location: T.5S. R.24E. Sec 6 S2 of Lot 8

Serial no. of notice: UTU 66357 (Hiko Bell project area) Is the operation active? No

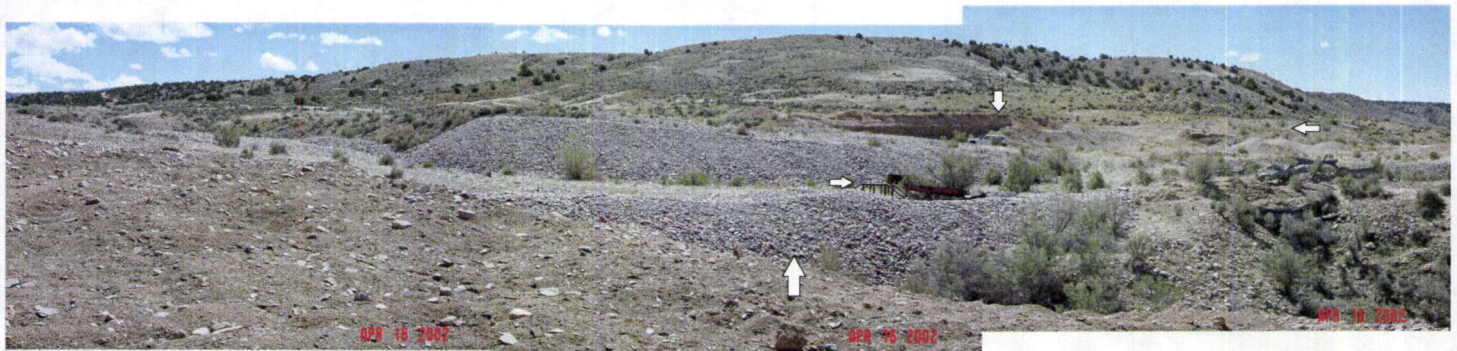
image 1 (above) - to east (at left) through southeast (at right) of oversized material in drainage (upward pointing arrow; some stockpiled oversized material just beyond), some material left on location (right arrow), eastern end of alluvial material excavated for processing (downward arrow, image 2 taken from a location right of this arrow), and stockpiles of fine sands, topsoil and pit-run material on southeast part of project area (left arrow).

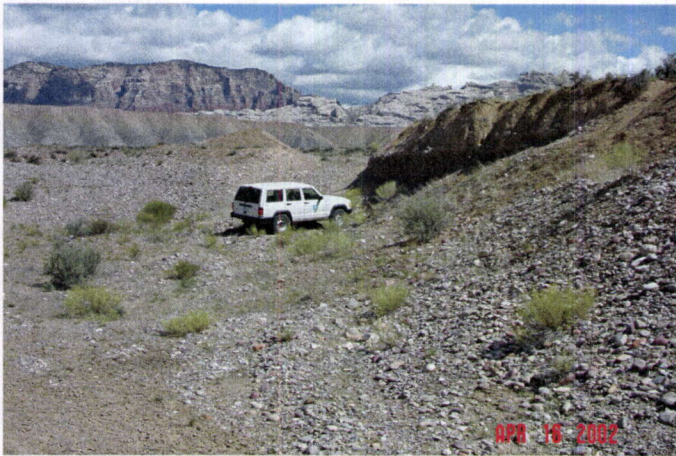
image 2 - view to north of eastern limit of excavated material (alluvial material which was removed for on-site processing), see vehicle for scale

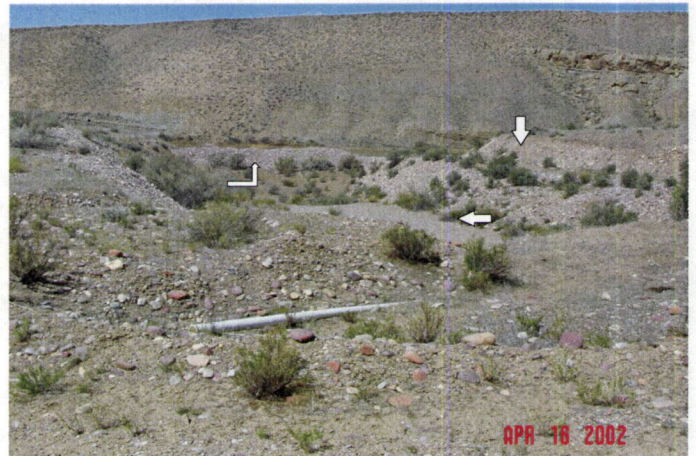
image 3 - view to west of [dried] settling pond area (left arrow), dammed by cobble rock (angle arrow); access to Green River is at right (down arrow; image 4 taken from the area of this arrow); residual pvc pipe at bottom-center

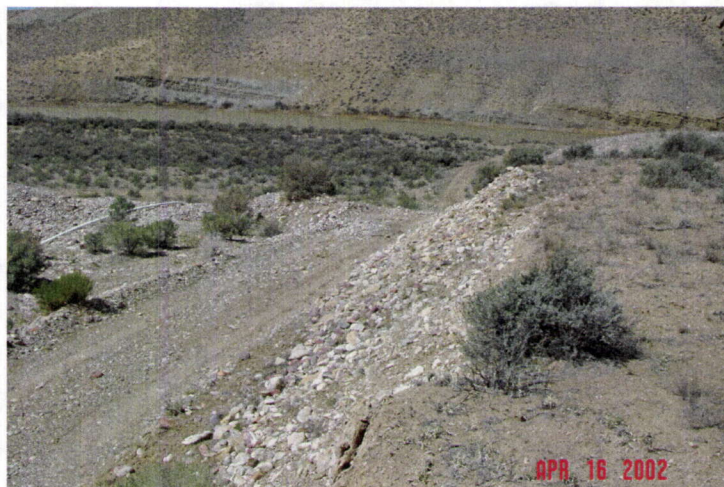
image 4 (below) - view to west of access road (part of the project and is required to be reclaimed); north end of cobble dam (in image 3) is at left-center (white pvc pipe laps over the top); Green River is across the top of the image.
